Published in:
Microbial Biotechnology

Bioprotection of the built environment and cultural heritage

Geoffrey Michael Gadd^{1,*} and Thomas D. Dyer²

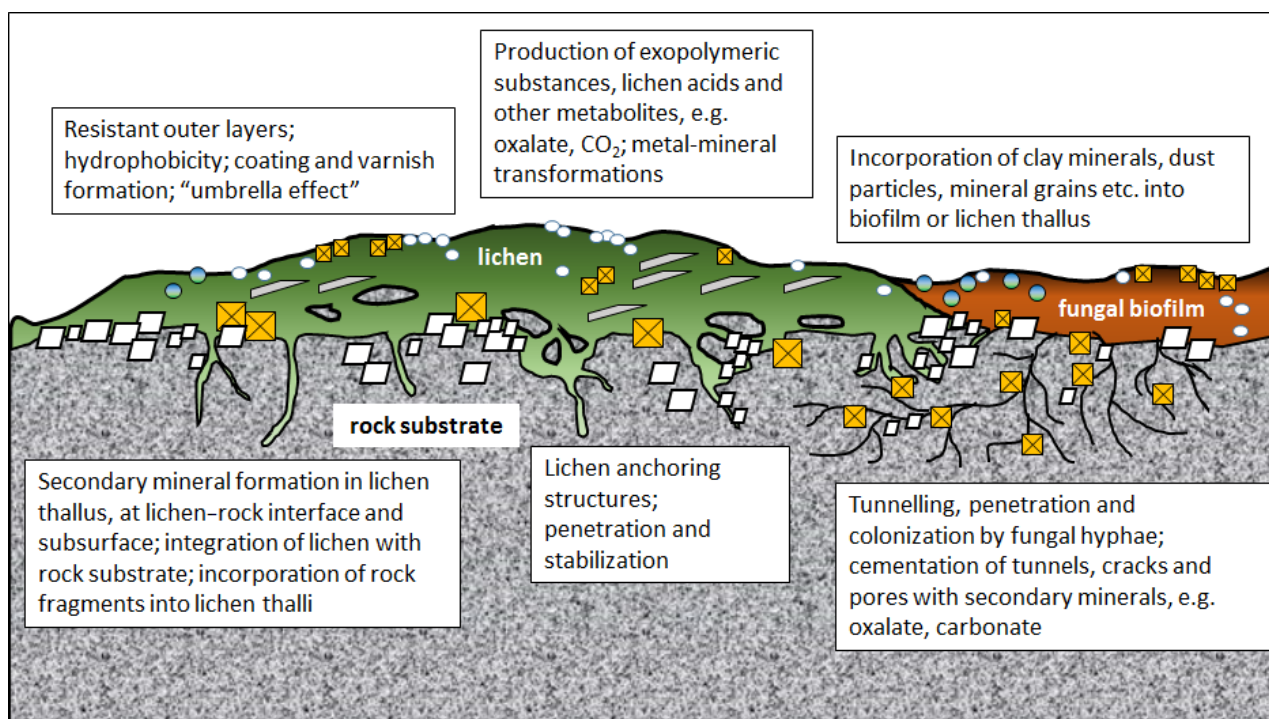
Fig. 1. Representation of possible mechanisms involved in surface colonization of rock- and mineral-based substrates by lichens and fungal biofilms. There may be wide variations in the nature of mechanisms involved depending on the lichen species, substrate and environmental factors. □, mineral formation, e.g. carbonate, in lichen thallus, rock interface or subsurface; ⊠, oxalate formation, e.g. calcium oxalate, in lichen thallus, rock interface or subsurface; ~, clay minerals; ●, other minerals, e.g. oxides; ○, miscellaneous dust particles, mineral grains.

Fungal systems are probably of most potential when considering bioprotection approaches, and there is considerable evidence to support this concept of utilizing natural or engineered colonization and metabolic properties of fungi, including lichens. Indeed, the accelerated deterioration of building stone and cultural heritage that can occur when such protective layers are removed is well known (McIlroy de la Rosa *et al.*, 2012; Gadd, 2017a). The bioprotective effect may take two forms – physical protection and biomineralization. Lichens, fungal biofilms and coatings may physically inhibit weathering of surfaces through shielding by the thallus ('umbrella effect'), binding of the rock surface by their anchoring structures or hyphae and through the accumulation of detached fragments in lichen thalli (Banfield *et al.*, 1999; Carter and Viles, 2005). Biomineralization can result from oxidation or reduction of a metal species. Additionally, the release of metals from rocks in mobile forms combined with reaction with reaction with metabolites can result in a variety of secondary mineral precipitates including carbonates, phosphates, oxides and oxalates (Gadd, 2010; Gadd *et al.*, 2014). Such biomineral formations contribute to rock coating development (Gadd, 2007, 2017b; Gorbushina, 2007; Fomina *et al.*, 2010) (Fig. 1).
